Utilization of on-line corrosion monitoring in the flue gas cleaning system

Published in:
Proceedings of NACE Corrosion 2015

Amager unit 1 is a 350 MW_{th} multifuel suspension-fired plant commissioned in 2009 which fires biomass. Increasing corrosion problems in the flue gas cleaning system have been observed since 2011 in both the gas-gas preheater and the booster fan and booster fan duct. A root cause analysis concluded that corrosion occurs due to corrosion products/deposit formed during operation; however it was unclear whether the majority of corrosion occurred during operation or downtime. In both cases the chlorine content in the flue gas results in the presence of chlorine species such as HCl, KCl or chlorine containing corrosion products. Without knowing when corrosion occurs, it is difficult to take reasonable measures to reduce corrosion. In order to gain an improved understanding of the corrosion problem, an on-line corrosion measurement system was established before the booster fan. The corrosion rates measured with respect to time were correlated to plant data such as load, temperature, gas composition, water content as well as change in the fuel used. From these r

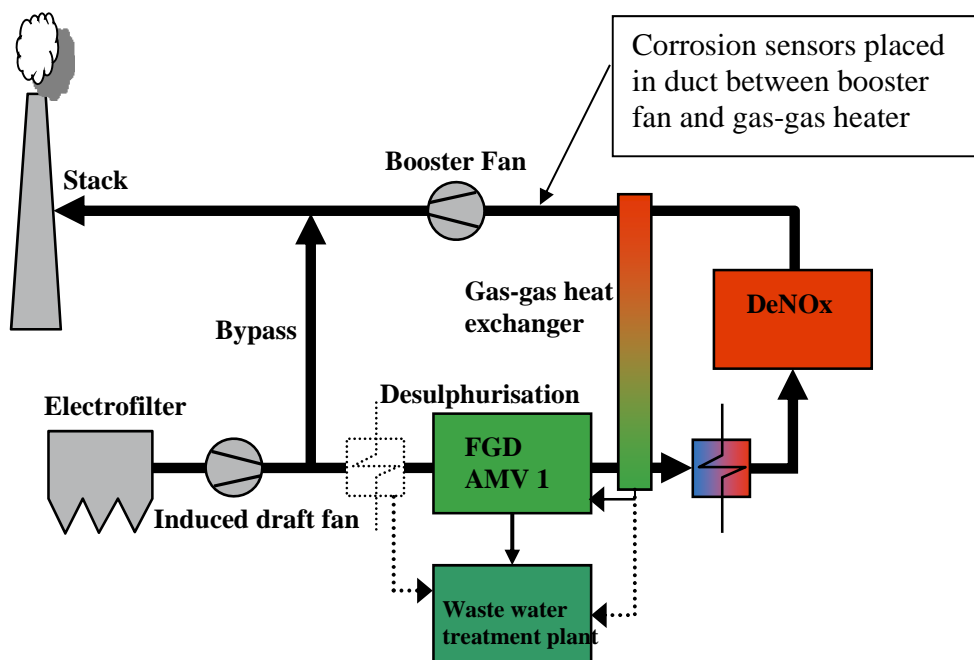
Figure 1: Schematic of flue gas cleaning system at Amager 1.

Figure 1 is a schematic diagram of the flue gas cleaning system (FGCS). The GAFO (gas/gas heat exchanger referred to in this paper as GAFO = “gasforvarmer”) is a rotating regenerative heat exchanger on a counter flow principle. Heat transfer elements in the GAFO are placed as a matrix in an open rotor which transfers heat from one gas side to the other whilst slowly rotating. Both the rotor and the heat transfer elements are fabricated in a weathering steel A242 with tradename CORTEN A¹. However in the lower part of the GAFO, these elements are further protected by an enamel coating. The inlet gas side is fabricated in UNS S31254 (254 SMO²) and the outlet “clean” gas side in A242 steel. Flue gas (~51°C) from the FGD plant is heated to approx. 300°C and led through the deNO_x plant. Then the “clean” gas returns to the GAFO heat exchanger where it is cooled to approx. 85°C and flows via the booster fan to the stack. The ducts after the GAFO are carbon steel, as is the booster fan.

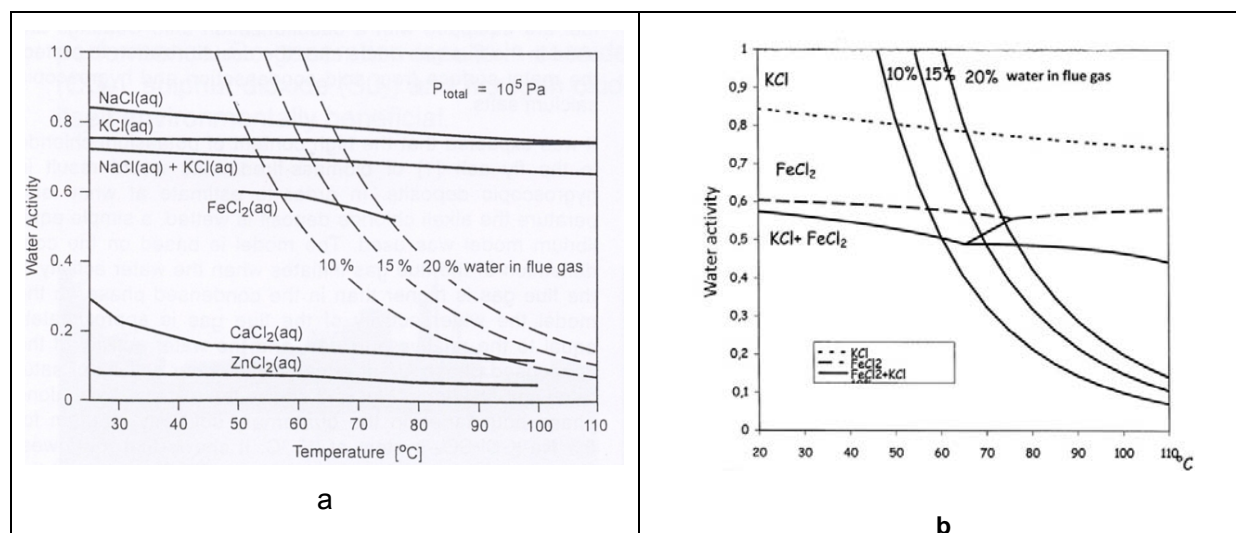
Figure 15: Water activity (activity water = relative humidity%/100) as a function of temperature for saturated salt solutions and flue gas a) taken from [5]⁵ and b) taken from [15].

Based on Figure 15a, CaCl_2 salts and ZnCl_2 salts are highly hygroscopic (as is FeCl_3 ¹⁶) and will form deliquescent salts at low water activities such that even at 100°C, these will give problems with corrosion. Alternatively KCl and NaCl require much higher water activities and will not form a saturated solution at the 15 vol.% water content in the flue gas. The corrosion product FeCl_2 is just slightly higher than the 15 vol.% flue gas, and as seen in Figure 15b, a mixture of KCl- FeCl_2 will give a soluble salt at higher temperatures. Thus corrosion occurs at operation at 85°C due to the formation of these potassium chloride-iron chloride mixtures. However as the HCl is removed from the system, this corrosion will cease. Yang measured the corrosion current of carbon steel at 45°C below KCl deposit with an increasing humidity.¹⁸ The corrosion current was minimal until the relative humidity was increased to 70%, which would fit with Figure 15a. When the humidity was decreased to 30%, the corrosion current continued, but at a lower extent for at least 12 days. This was probably due to the fact
